San Pedro Creek Watershed Assessment and Enhancement Plan

Prepared for
California Department of Fish and Game

March, 2002

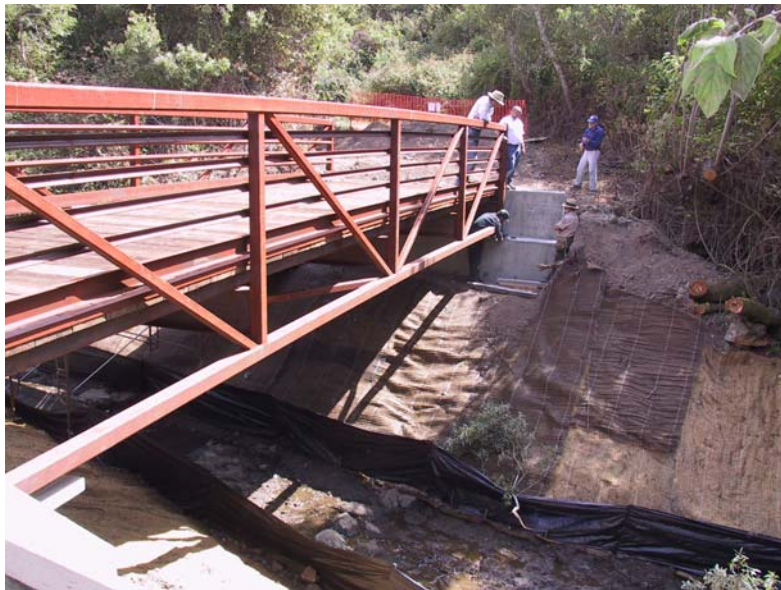
On July 29, 2001, the Parks and Recreation Department of the County of San Mateo (County Parks) and the San Pedro Creek Watershed Coalition (SPCWC) began removal of a 26' concrete culvert from the middle fork of the San Pedro Creek in San Mateo County, California. The culvert and the overburden were removed and construction started with the goal of replacing the culvert crossing with a free-spanning bridge that is 45' in length. The existing 6-foot deep plunge pool on the downstream side of the culvert under the existing bridge was a barrier to fish migration and movement. Additionally, stream banks have been degraded due to eddying behind the culvert and accelerated stream flows exiting the culvert. The upper reaches of the middle fork and its tributaries provide ideal habitat for steelhead spawning and rearing. By replacing the existing earthen trail crossing and culvert in the middle fork of San Pedro Creek with a new, free-spanning, 45-foot long bridge, we will be able to stabilize and repair the Creek banks, recontour the slopes, plant native vegetation to reduce soil erosion, and improve wildlife habitat. Supporters of the project have included: SPCWC, City of Pacifica, San Mateo County Parks and Recreation Department, National Fish and Wildlife Foundation, Urban Creeks Council, Regional Water Quality Control Board, and the San Mateo County Parks Foundation.

Fig. 2. Bridge Project in San Pedro Valley County Park (Photograph by Jerry Davis 2001)

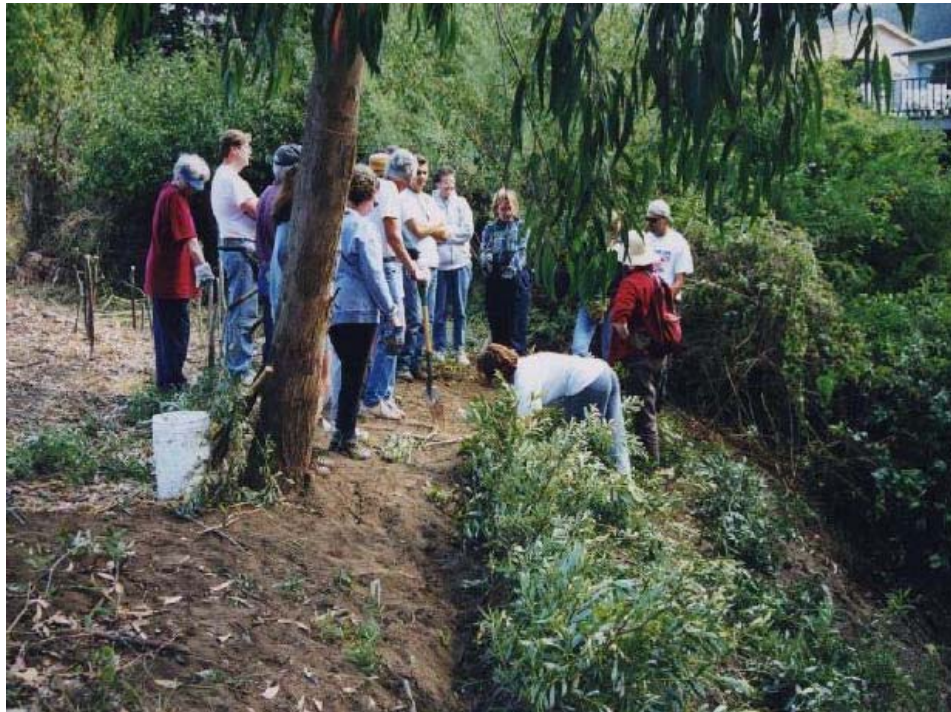
Fig. 3. Bioengineering workshop at San Pedro Creek, 1999. (Photograph by Christine Chan)

The San Pedro Creek Watershed Coalition held a four-day bioengineering workshop in the fall of 1999. Ann L. Riley, of the Waterways Restoration Institute in Berkeley California, conducted the workshop, which was meant to teach city officials and private landowners how to naturally and effectively stabilize eroding banks along San Pedro Creek. The following photograph illustrates a Brush Layering technique that was taught at this workshop. (Chan, 2000).

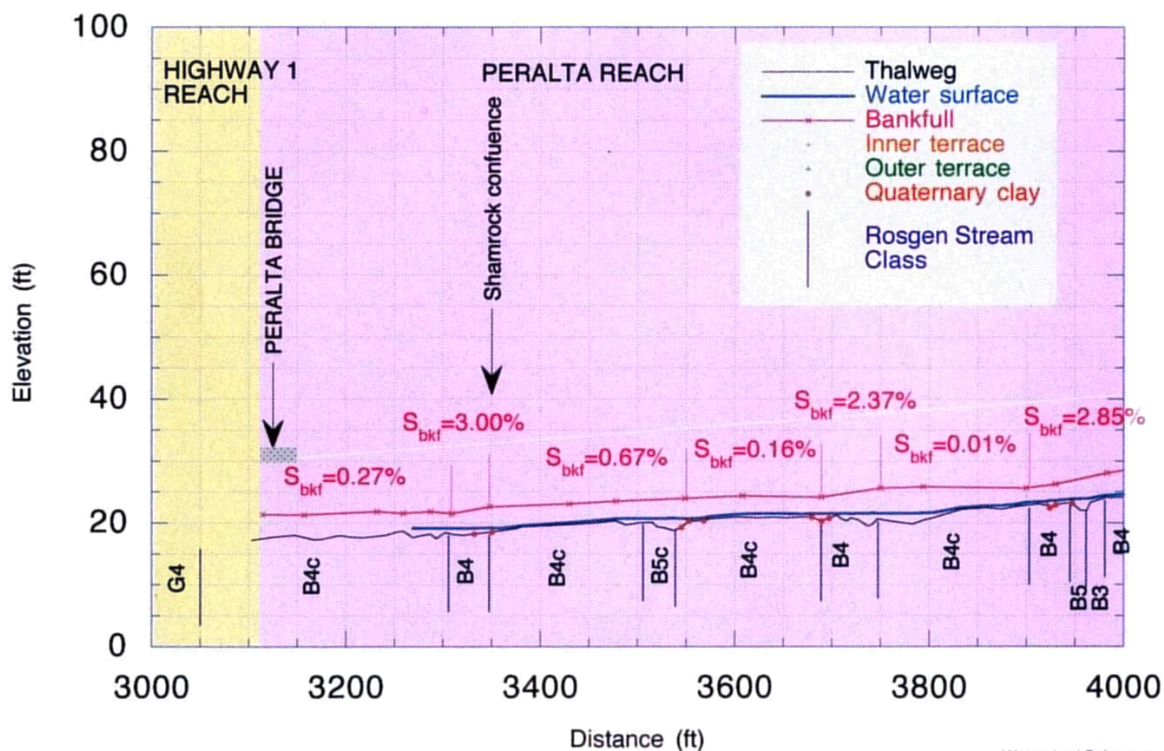
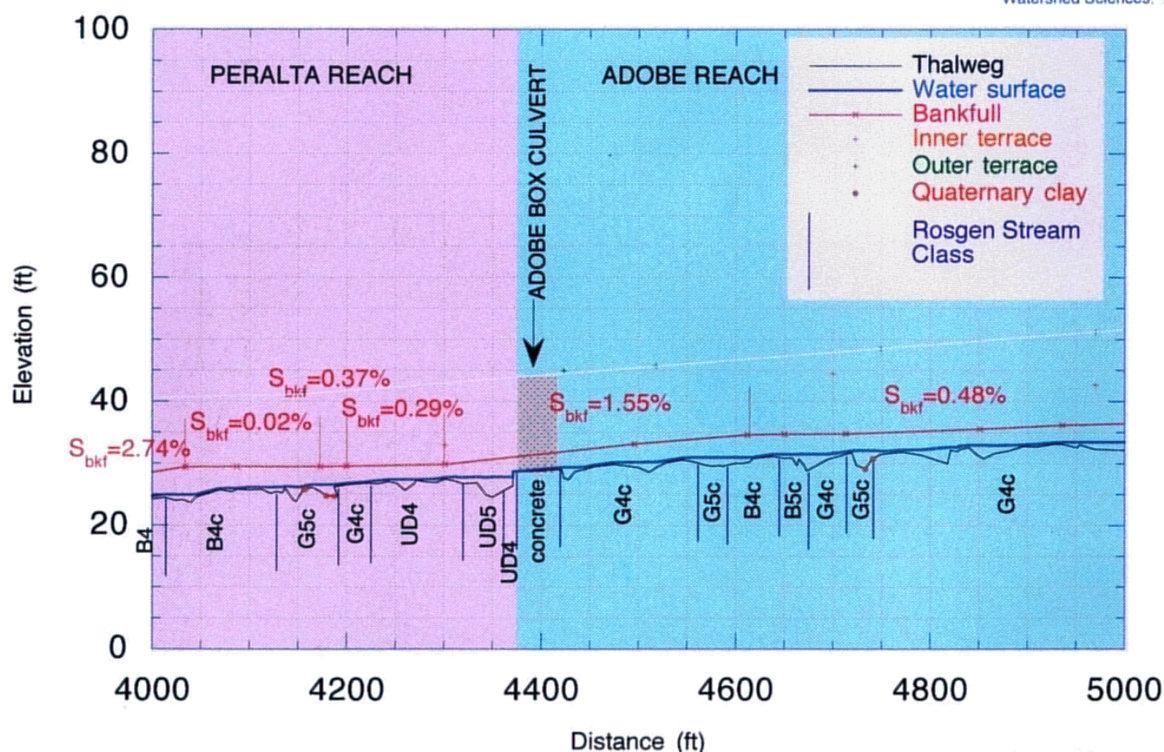
SAN PEDRO CREEK LONGITUDINAL PROFILE WITH STREAM REACHES AND ROSEN STREAM CLASSES FOR 2.6 MILE STUDY SITE

Elevations surveyed during Fall 2002 by Jerry Davis, San Francisco State university, and Laurel Collins, Watershed Sciences

Fig 10. a-b. Profile, gradients and Rosgen class, 3000-5000 ft. from mouth (L. Collins.)

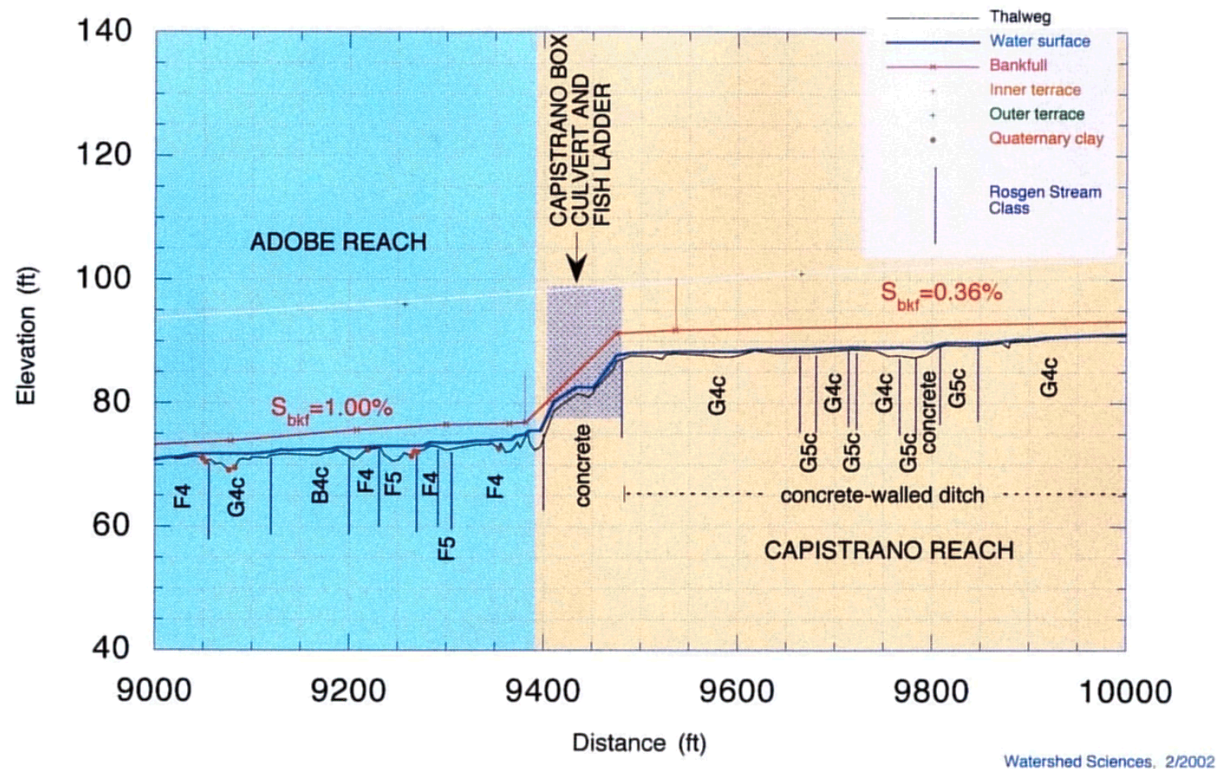
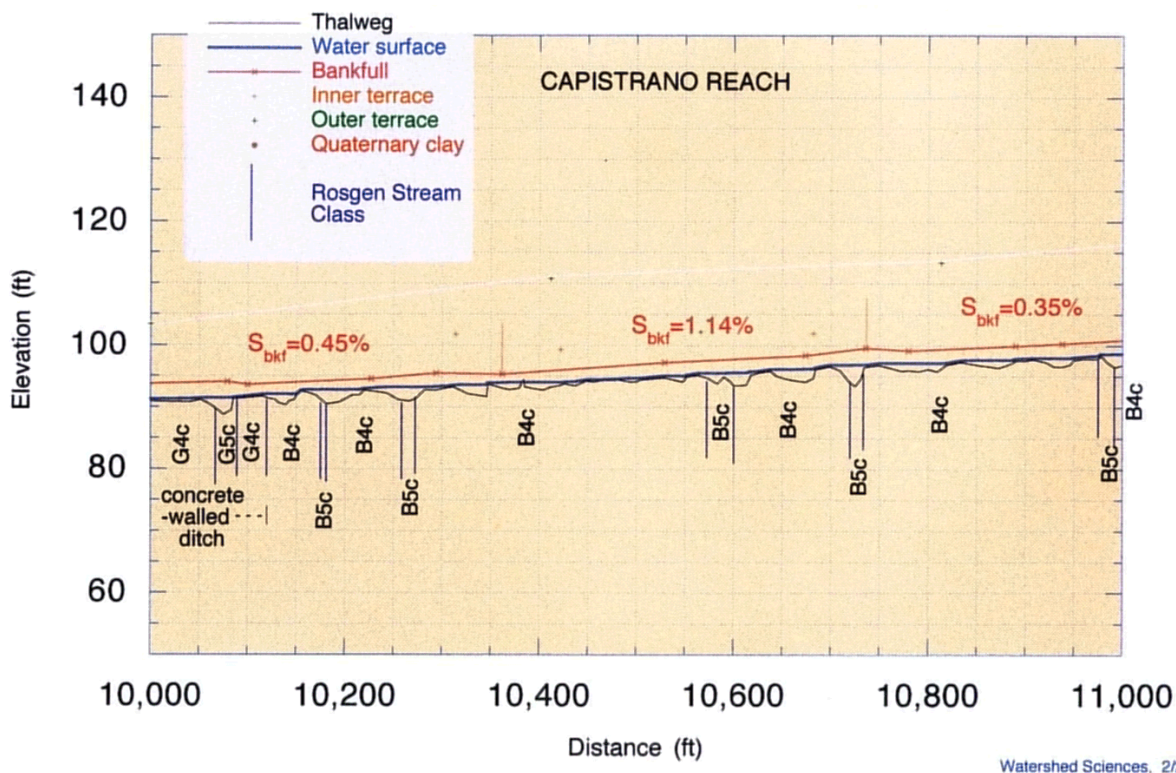
Fig 10. g-h. Profile, gradients and Rosgen class, 9000-11000 ft. from mouth (L. Collins).

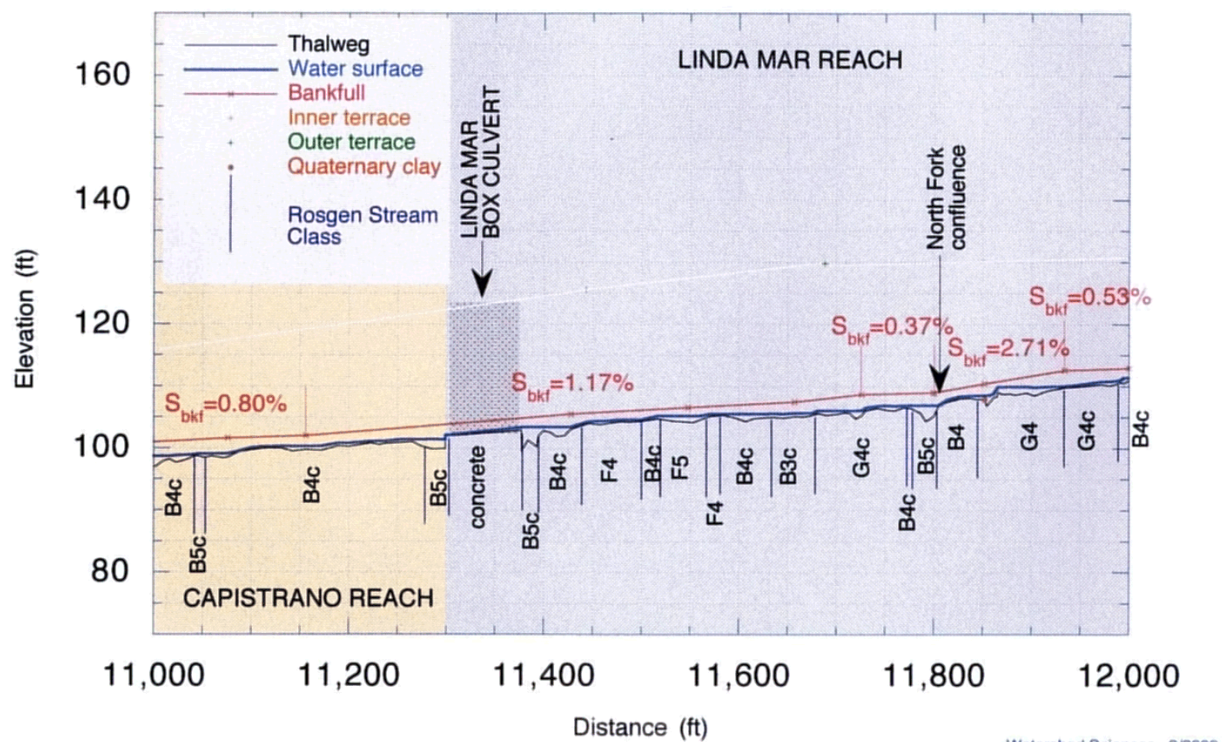
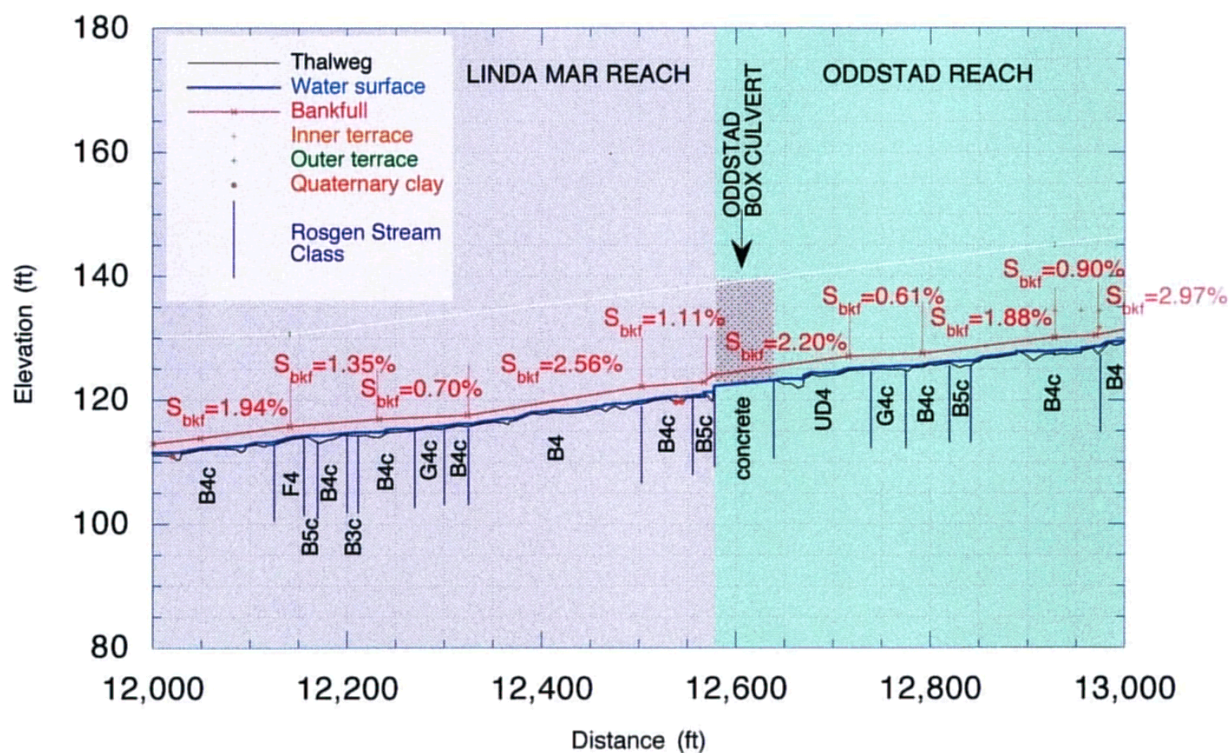
Fig 10. i-j. Profile, gradients and Rosgen class, 11000-12000 ft. from mouth (L. Collins).

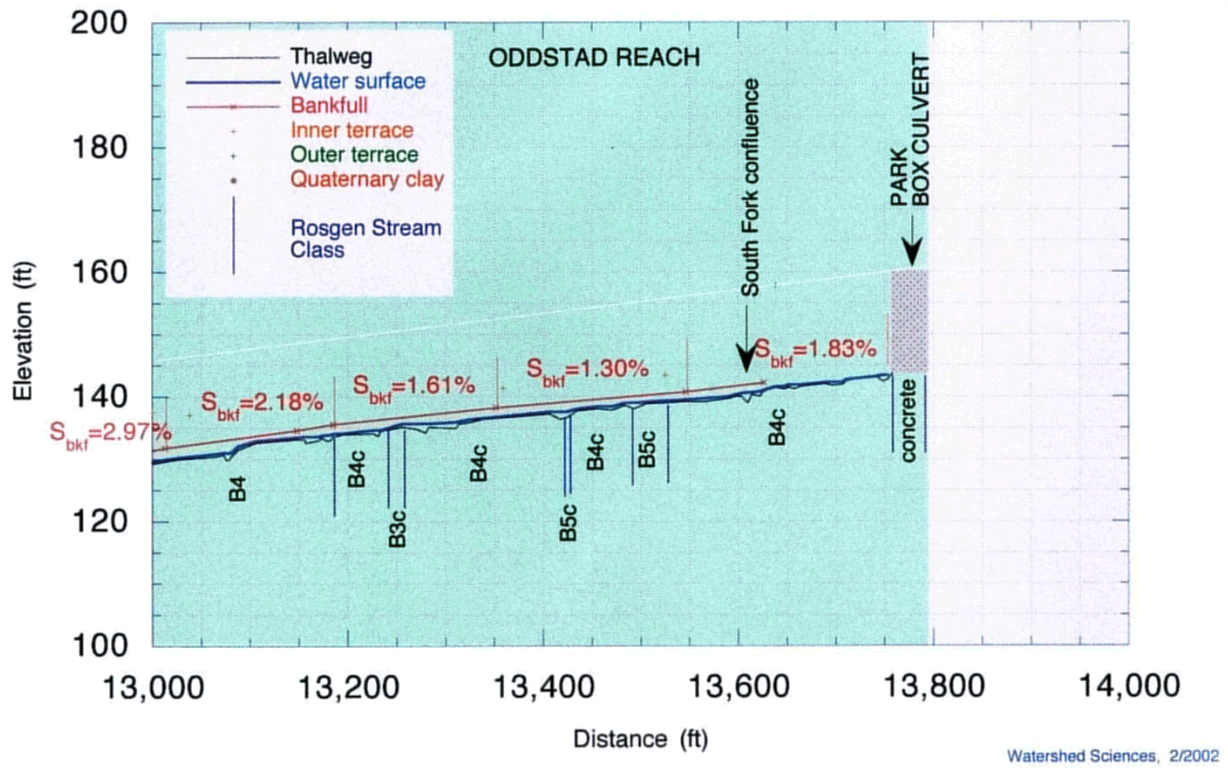
Fig 10. k. Profile, gradients and Rosgen class, 13000-13800 ft. from mouth (L. Collins).

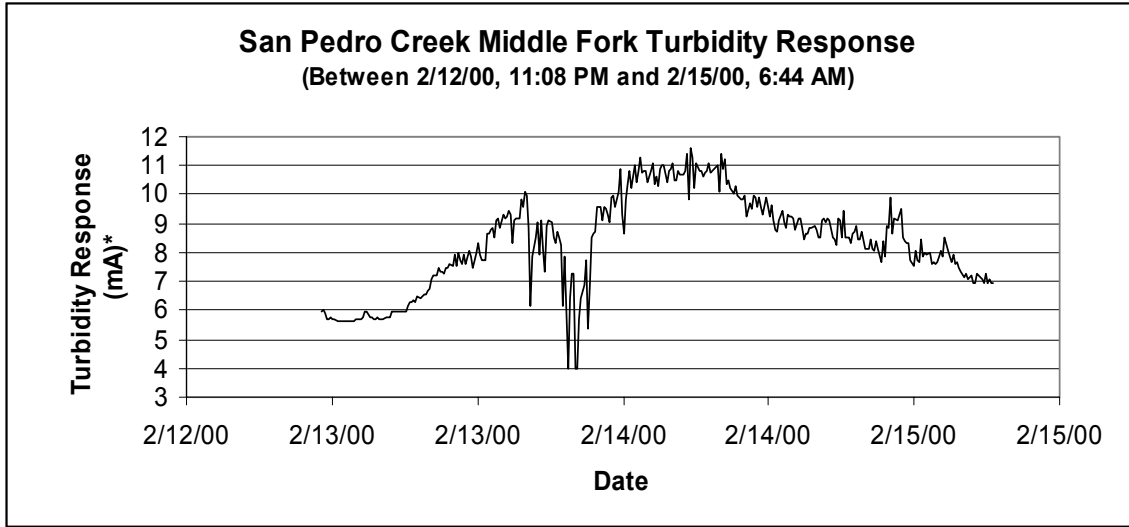
The overall turbidity levels are also less in the North Fork than in the Middle Fork. This can be attributed to reduced sediment sources due to increased impervious area and reduced natural channel bed and banks in the North Fork.

Figure 14. San Pedro Creek Middle Fork Turbidity Response

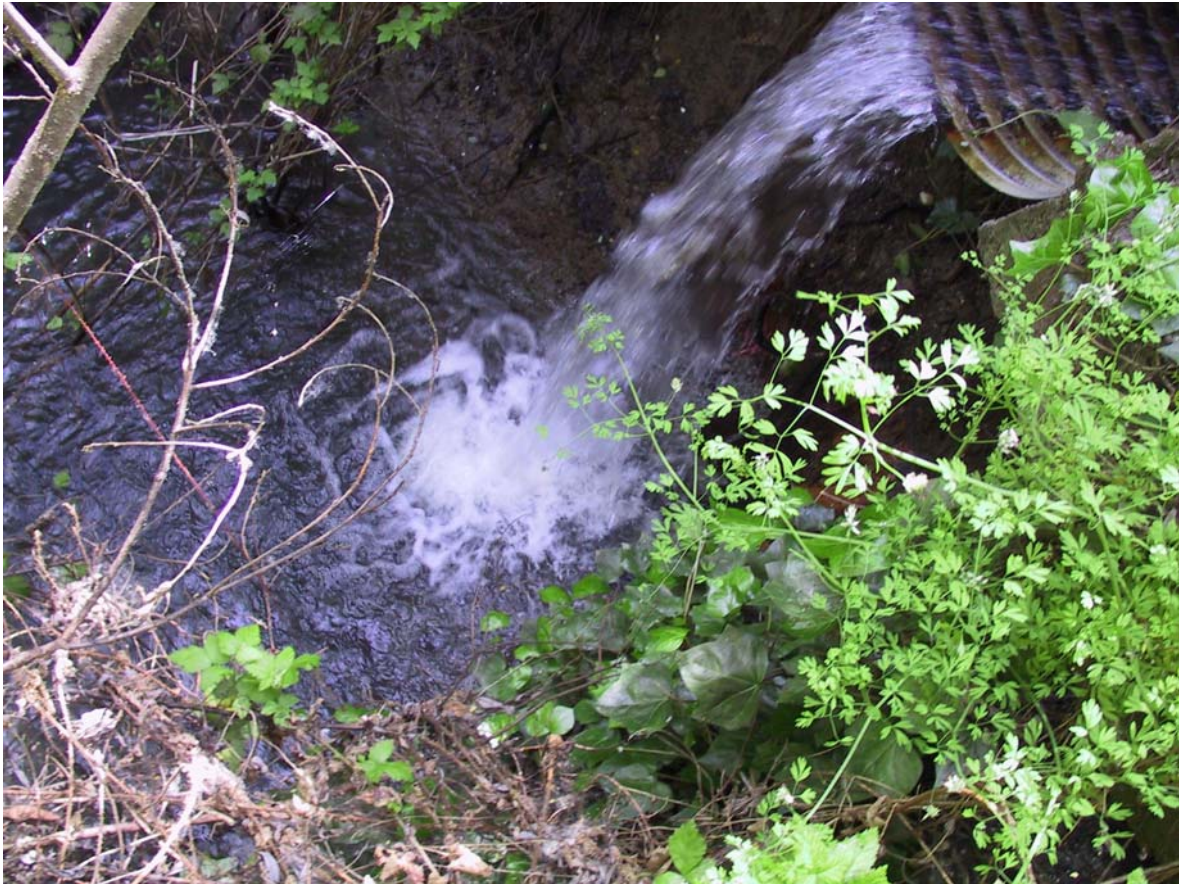
Other barriers exist in tributary watersheds. For example, most of Sanchez Fork is blocked by a substantial drop from a 6' corrugated culvert under a church parking lot (Figure 19).

Figure 19. Sanchez Fork Barrier (photograph by Jerry Davis, 2002)
