# **Steelhead Habitat Assessment For The San Pedro Creek Watershed**

**Steelhead Habitat Assessment  
For The San Pedro Creek Watershed**

San Pedro Creek Watershed Coalition  
c/o Christine Chan, Projects Coordinator  
122 Hilton Lane #3  
Pacifica, California 94044

February 15, 2002

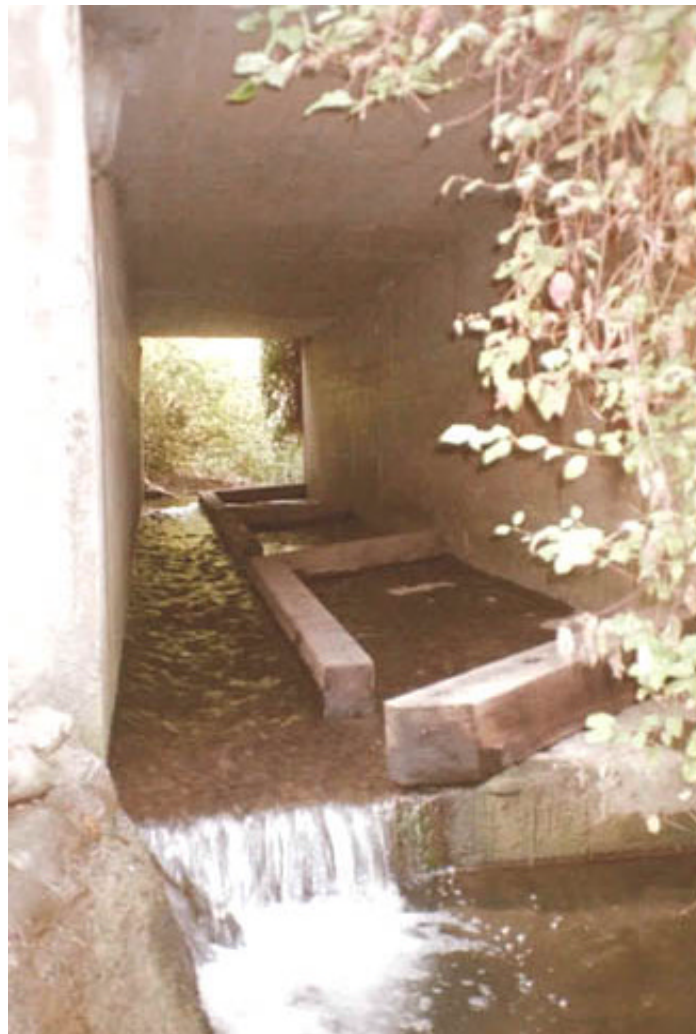
**Figure 9. Adobe Road Culvert**

There are four potential migration obstacles in the mainstem of San Pedro Creek, each at a bridge crossing. The first, at Adobe Road is a 7.5 foot wide box culvert that has been retrofit with wood beams on the floor of the culvert to enhance fish passage (Figure 9). The Adobe Road culvert appears to be an obstacle to steelhead migration only at relatively low flow levels.

The Adobe Road culvert is approximately 50 feet in length and has a gradient greater than 0.5%. Under these conditions guidelines call for minimum depth of flow of 12 inches during adult steelhead passage periods and 6 inches during juvenile passage periods. Average velocity should be less than 6.0 feet per second (fps) for adults and less than 1.0 fps for juveniles. The Adobe Road culvert is perched by approximately 1 foot, which would be acceptable for adult passage provided that water depth and velocity in the culvert are satisfactory and that there is a pool with minimum depth of 2 feet immediately below the culvert outfall. Under higher flows expected during adult migration periods, the jump height would be reduced and the pool depth increased. Additional backwatering during low flow periods using placement of downstream hydraulic controls could improve passage potential for juvenile steelhead.

Several road crossings present potential passage obstacles. These should be evaluated to determine under what flow conditions passage guidelines are met and how often those conditions are expected to occur at each site. This will enable prioritization of enhancement projects to target those with the shortest passable periods first.

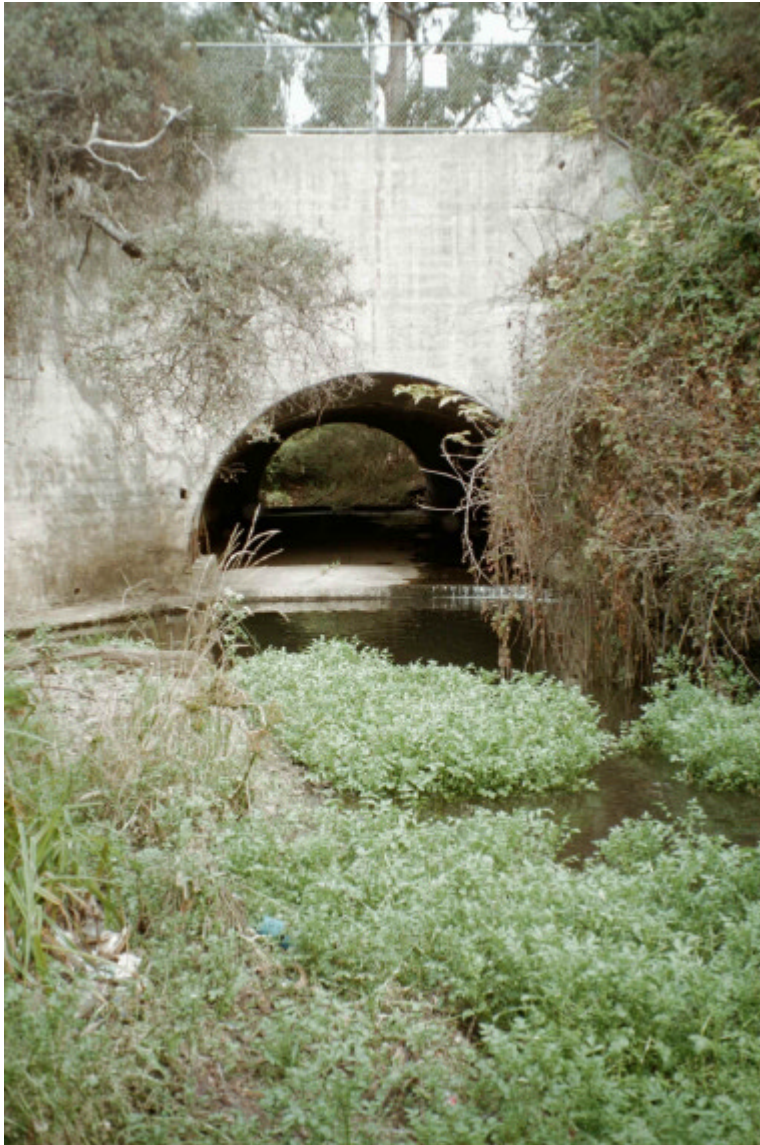
**Figure 11. Linda Mar Bridge**

The third migration obstacle is formed by the Linda Mar Bridge. The culvert is approximately 76 feet long and 16.5 feet in width with an even concrete bottom. The culvert is slightly perched (about 0.5 feet) and the wide, flat floor would result in shallow flow depth at most lower flows (Figure 11). The 3% gradient is not consistent with National Marine Fisheries Service (NMFS) passage guidelines and may result in excessive flow velocity at higher flows. The Linda Mar Bridge was judged to be an obstacle to upstream migration at most flows for both adults and juveniles.

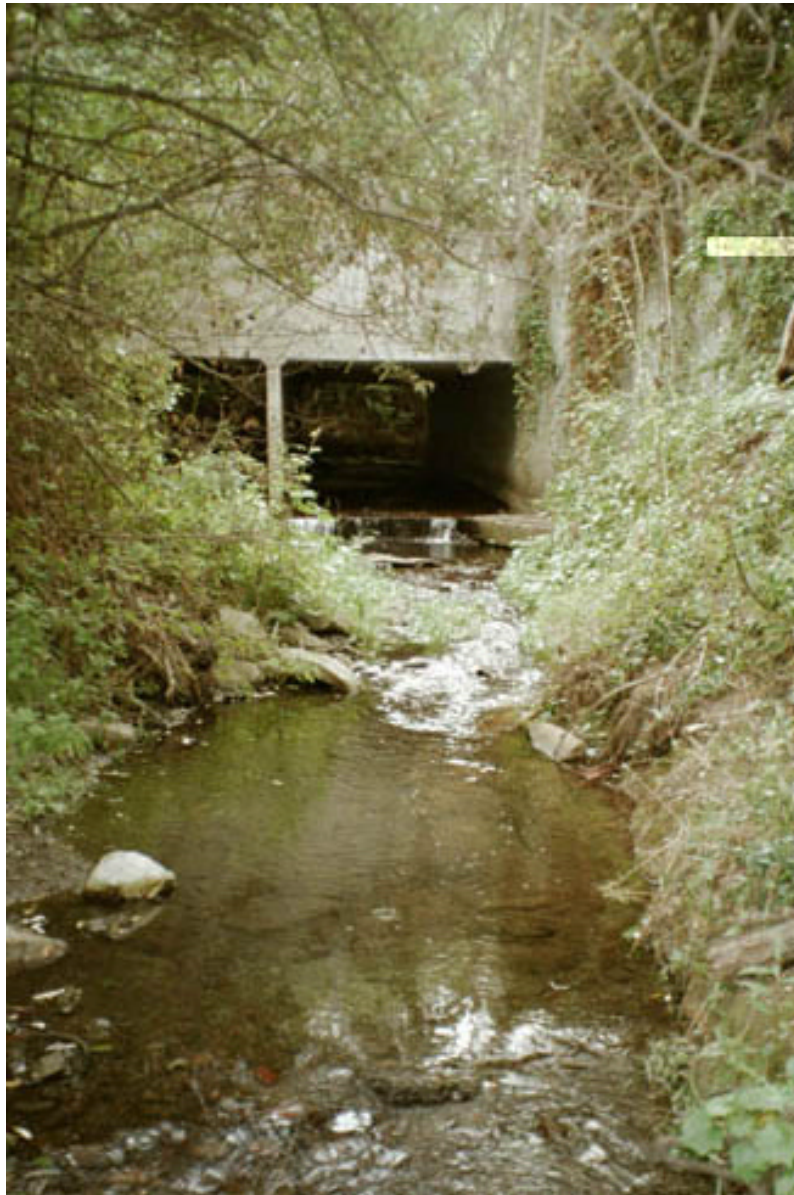
**Figure 12. Oddstad Road Culvert**

The last migration obstacle on the mainstem is at Oddstad Bridge and is also judged to be a barrier to upstream migration of both adult and juvenile steelhead at most flows (Figure 12). The

roadbed rests on a double concrete box culvert with each bore approximately 64 feet in length and 10 feet in width. The right bore has a lot of sediment accumulated in it and most flow is through the left bore. The culverts were perched by about 1 foot at the time of the survey and the gradient was measured at about 2%.

The Oddstad Bridge culvert is not likely to meet depth and velocity conditions recommended for adult or juvenile steelhead passage during all periods when fish may be migrating. This should be further evaluated to determine the degree of passage obstruction relative to the other obstacles. Critical features include the width (20 feet including both bores), gradient (approximately 2%), and jump at the downstream side. This obstacle is relatively high in the watershed and, with less contributing watershed area, will not experience flows as high as those occurring at the lower migration obstacles.

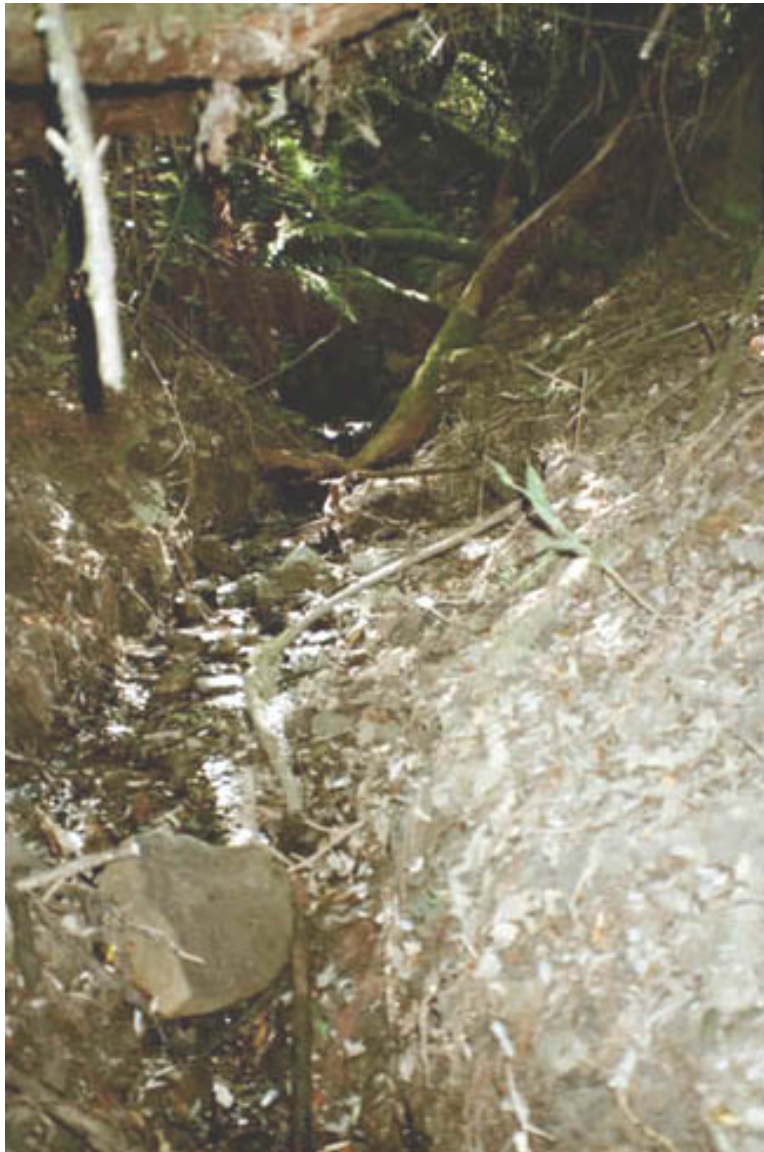
**Figure 13. Middle Fork Southern Branch**

of the branch, the Middle Fork had become just a trickle of flow between pools with a wetted width of only about 2 feet and the channel was densely overgrown with willow, dogwood, and other shrubs. The southern branch was also just a trickle with little standing water (Figure 13). There were some debris jams in the lower part of the southern branch with cascades to about 2 feet high. Bankfull width in the southern branch was about 3 feet and no fish were seen. The southern branch provides little if any habitat for steelhead. Although the Middle Fork upstream of the southern branch was also very small, there were pockets of standing water and young-of-year steelhead/rainbow trout were present for at least 400 feet upstream of the southern branch. At that point the stream was becoming intermittent, was steeper, and had little habitat for fish. This was considered the upper limit for anadromous fish in the Middle Fork.

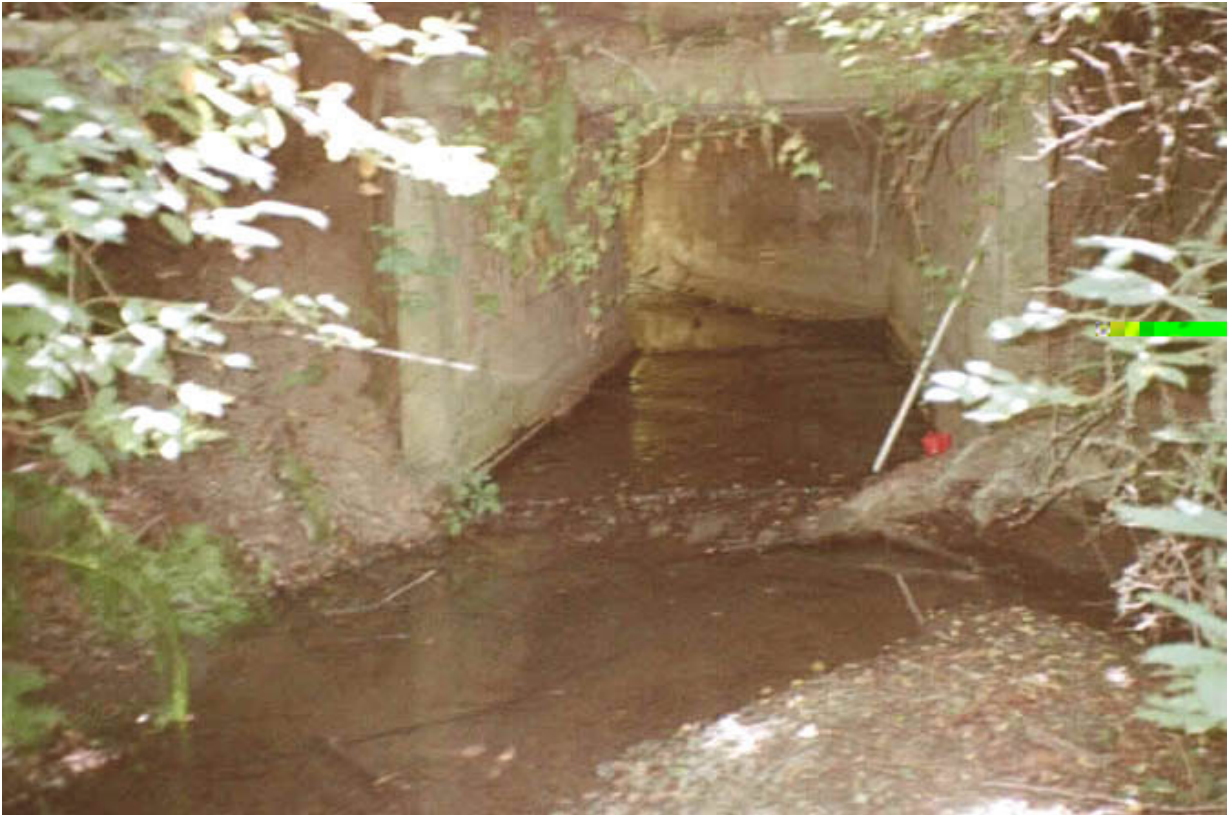
**Figure 14. Lower Middle Fork Culvert**

In the Middle Fork, only one potential passage obstacle was identified. This was the culvert at a fire road/footpath crossing in the Park picnic area (Figure 14). The culvert is relatively short (38 feet), about 8 feet wide and has a gradient of about 2%. There is a 45° bend about half way through the culvert that would induce some variation in flow velocity and enhance passage potential. The culvert was perched by about 0.5 feet at the time of the survey. This culvert was judged to be a potential obstacle to adult steelhead at low flows only but is possibly a barrier to upstream migration of juvenile steelhead at most flows.

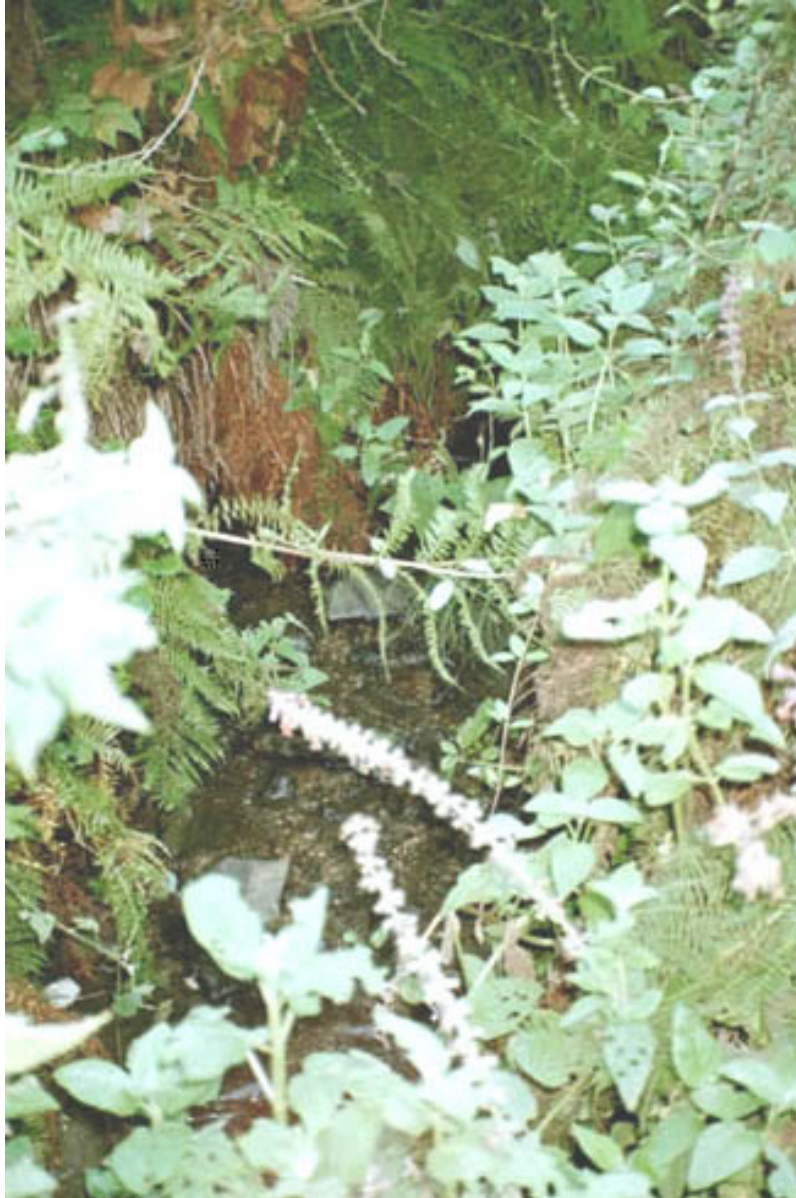
**Figure 15. Lower South Fork**

Two reaches of the South Fork were surveyed. Dense brush obstructed the stream channel in many locations and only a portion of both reaches were sampled (Figure 15). The first reach extended from the confluence with the Middle Fork to the first main branch. The second reach was the east branch up past the North Coast County Water District diversion point and upstream

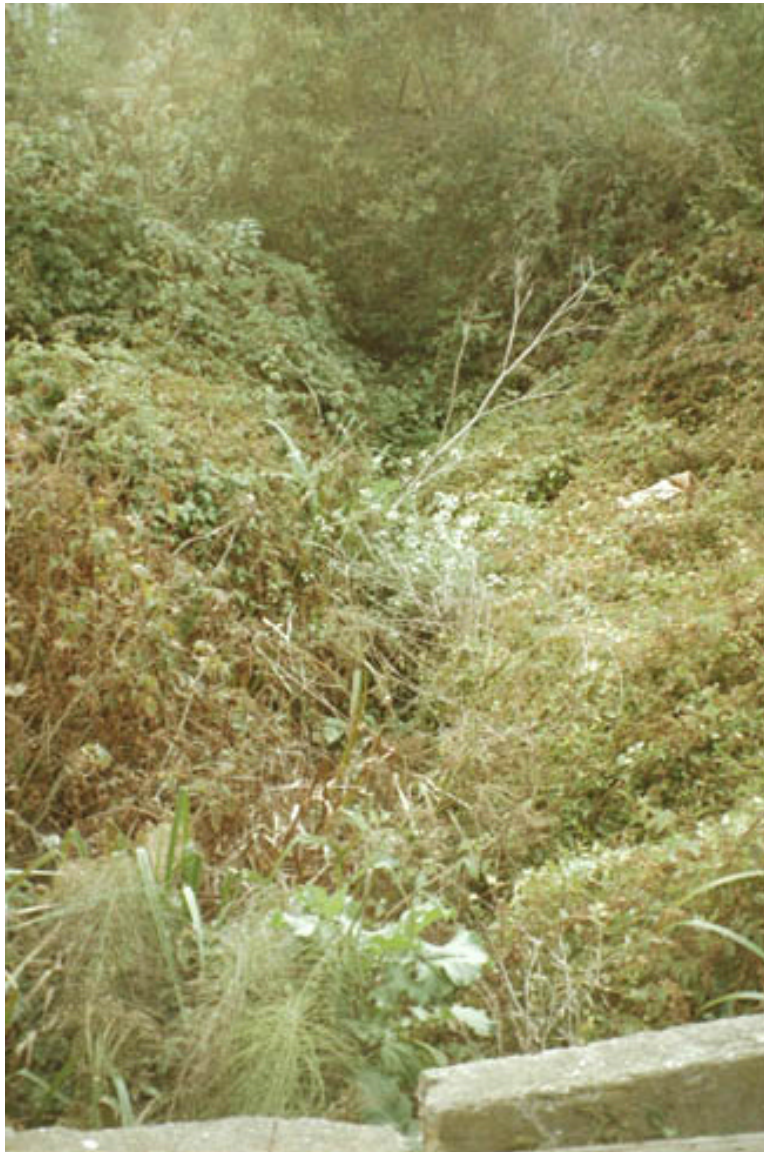
**Figure 17. Shamrock Branch above Linda Mar School**

immediate stream channel consists mostly of grassy fields on the valley floor and scrub on the side slopes. The valley floor appears to be rather intensively used for livestock and equestrian activities. There is a low earthen dam in the upper part of the watershed but the pond held no water at the time of the survey.

The Shamrock Branch appears to have little or no potential to support steelhead/rainbow trout. Nevertheless, activities in the watershed have the potential to contribute to water quality, streamflow, and sediment conditions in the mainstem and in that way, conditions in this sub-watershed are important to maintenance of steelhead/rainbow trout populations in the lower mainstem.
